NEW BUILD HOME SNAGGING INSPECTION

24 Park Way, Grange Heath, Co. Dublin

Sunday 13 February 2022

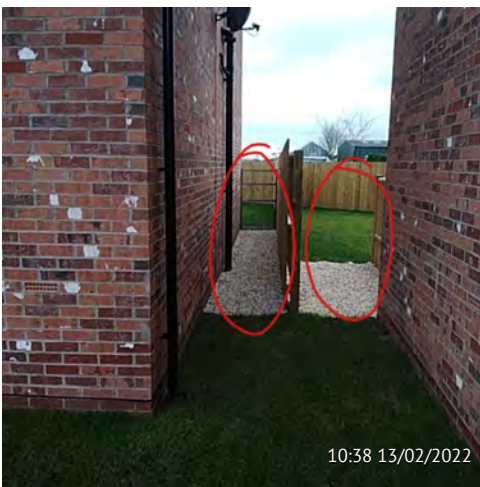
2 Front Garden

Ground firm and dry on day of inspection

Evidence of previous water logging....turf thin and dying offbuilder investigate / comment

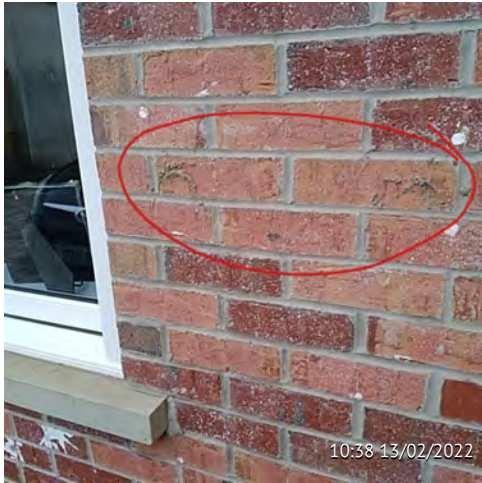
4 All Window Cills

Poor window cill designwindows cills should
Not encourage water to sitthis causes long term damage to stone
and concrete

Cills should be designed to shed water away from the property by
means of a sloping cil. And and underside dripthis detail used may
be the local vernacular ... but its not good design

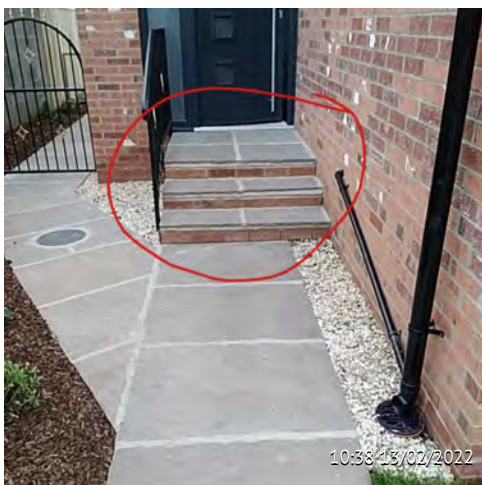
6 LHS front Elevation

Seal gapsmastic sealant required around

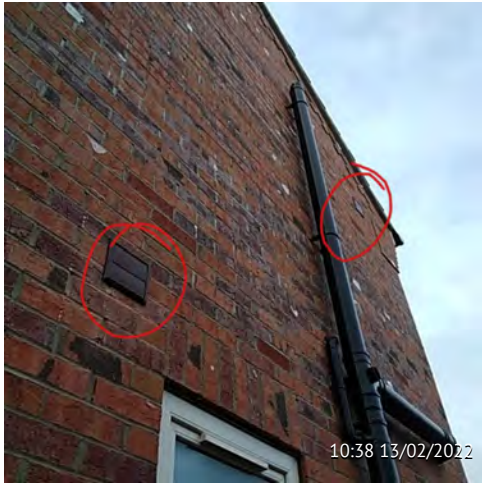
13 LHS Elevation

Sealant missing

Clip cables in position

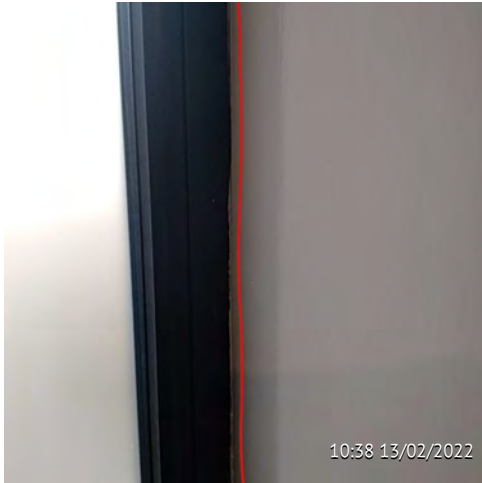
22 FED

trade Remove Excess Paint From The Door

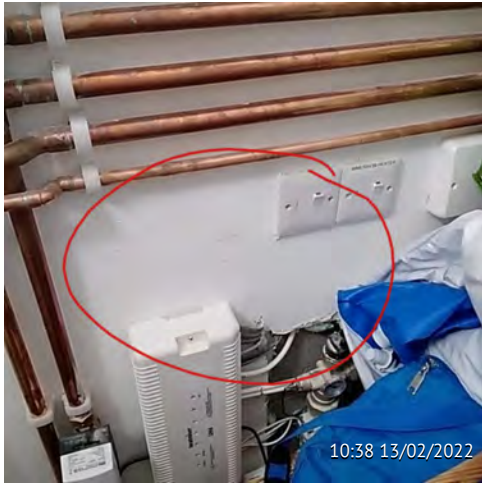
34 Lounge

Hot water running off immersion system only

There is no insulation fitted to the hot side cylinder pipework

Installation has no signed certificate on side of unventilated cylinder

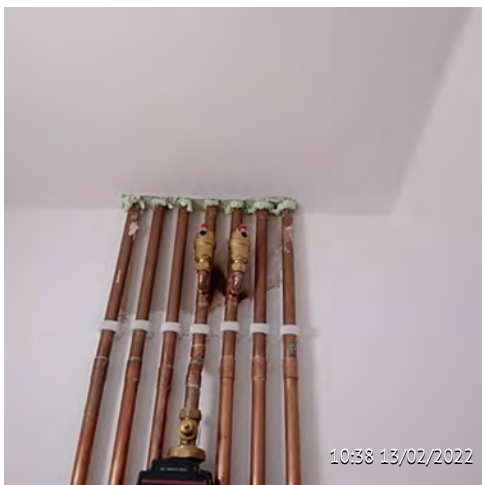
35 Lounge Cupboard

Decorative finish inside storage cupboard is poor

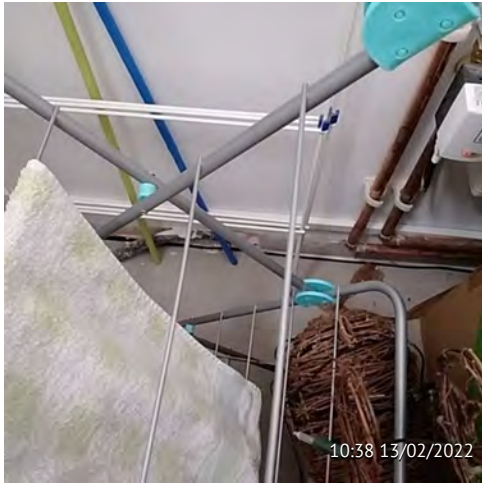
37 Lounge

Filling loop should not be connected when not is use

Commissioning certificate not signed

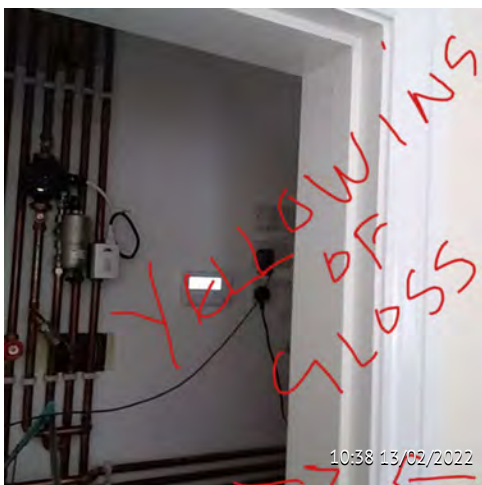
39 Typical Door Frame

Note premature Yellowing of paint finish.....caused by lack of daylight to paint , builder should choose paint formulations that can last the defects liability period

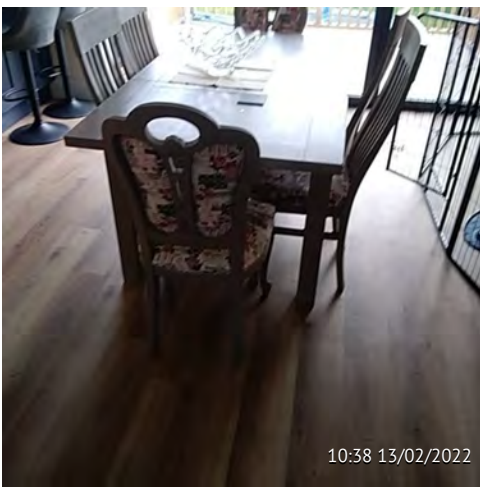
42 Lounge

Door stop required to prevent damage to wall

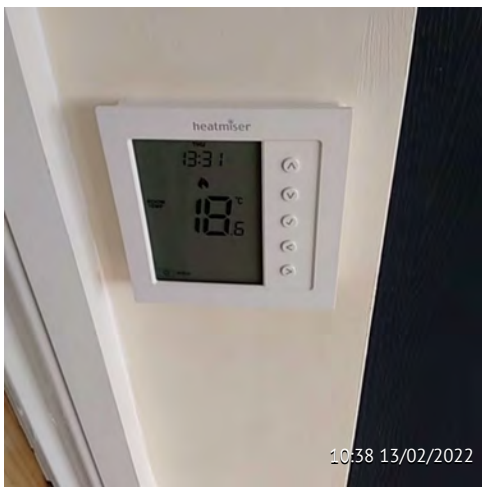
45 Lounge

The lounge floor whilst reading 18degrees on the cameradoes not appear to be operating at the same level as dining room

Stat for room is set at 18degrees, inspector could not raise the temperature above this point

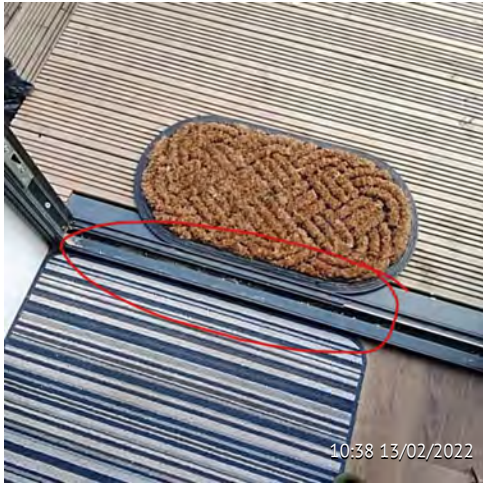
47 Hallway : Door To Kitchen

Door Rattles In Frame

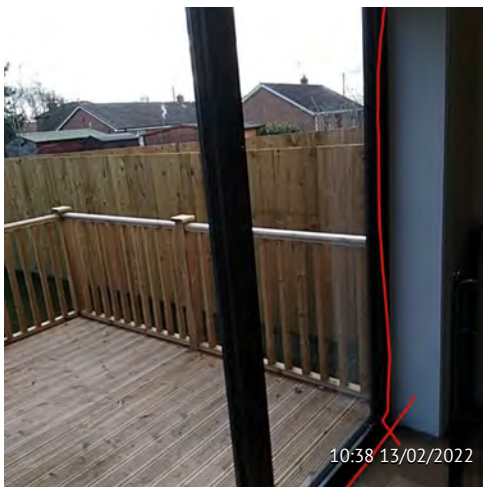
48 Dining Room

Gasket/ trim missing

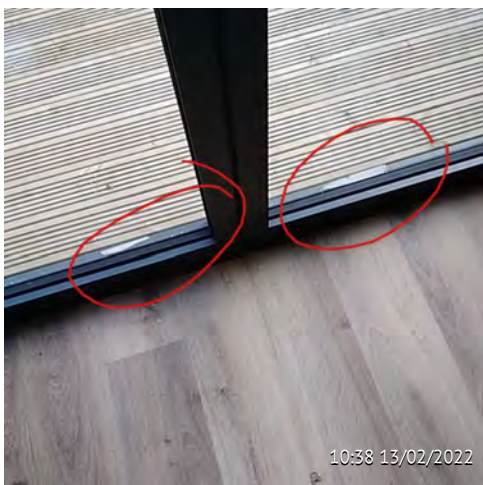
49 Dining Area

Mastic sealant required

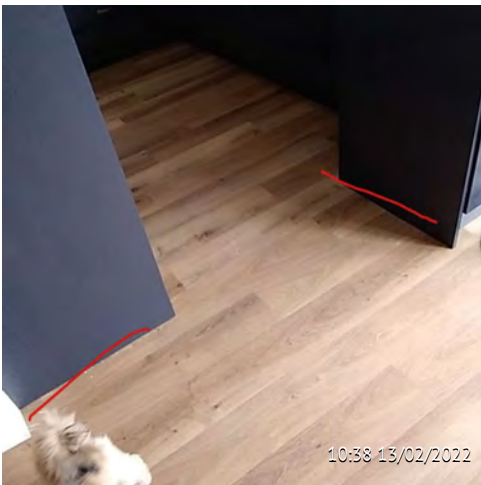
51 kitchen
trade Decorator
Mastic seal required

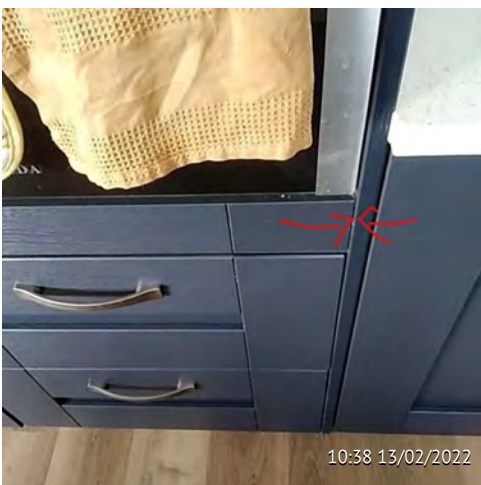
55 Kitchen

Marks in cabinet door

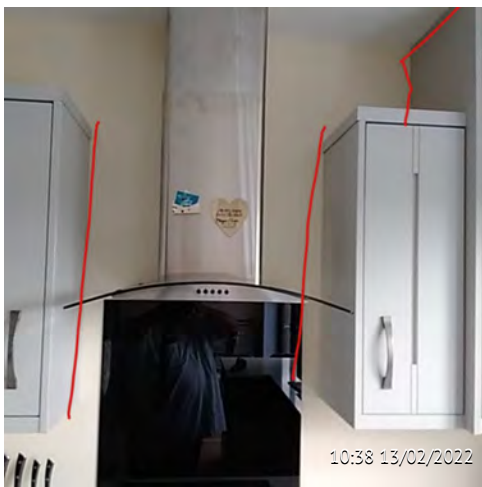
57 Kitchen

Cover cap missing

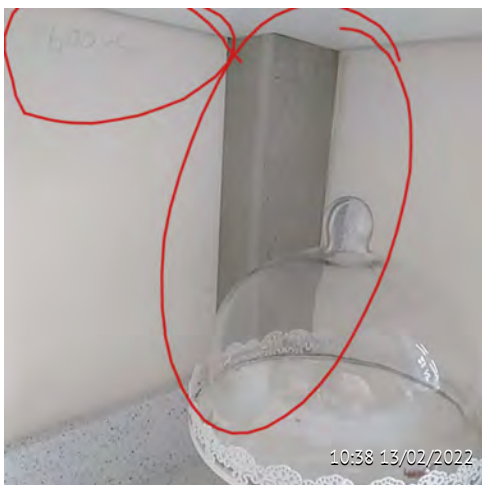
58 Kitchen

Mastic sealant required

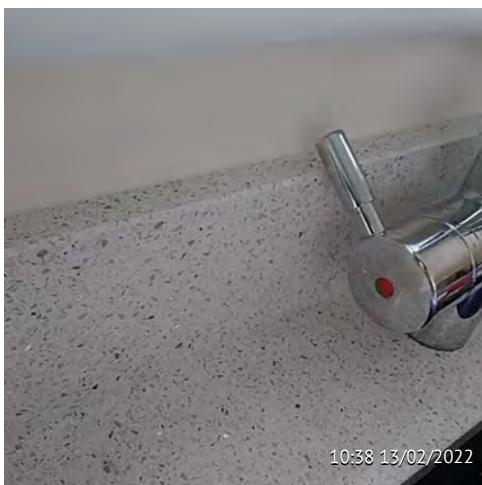
64 Kitchen

Tap loose

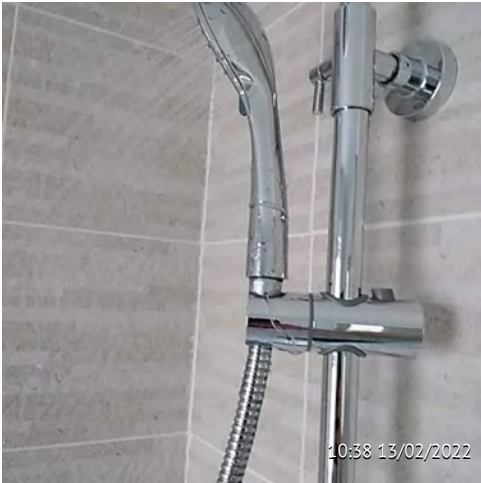
71 Bathroom

Mastic sealant required around the perimeter of the room

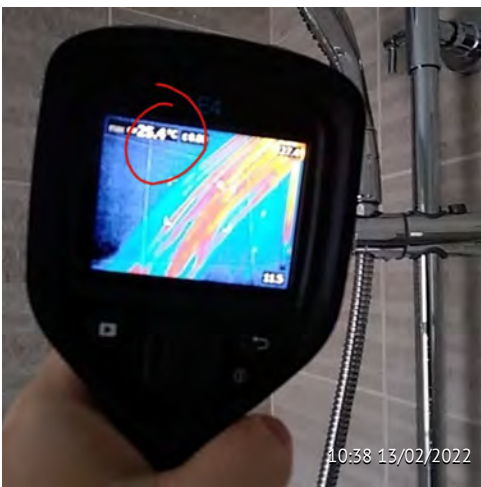
72 Bathroom
trade Plumber
Leak from handset

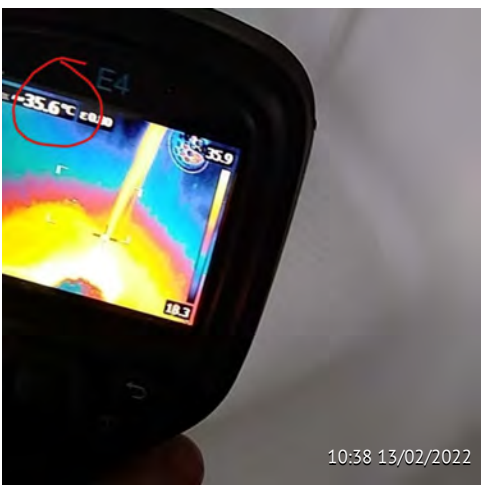
74 Shower
trade Plumber
Low water temp

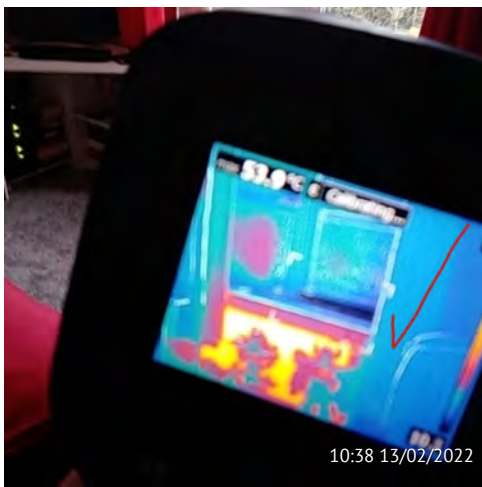
110 Front Bedroom Ceiling

Builder to investigate and comment on results of thermal imaging ...all rooms of this side of the building show a heat loss in the loft along the line where wall meets ceiling

Suggests insulation is not consistent at this point in loft

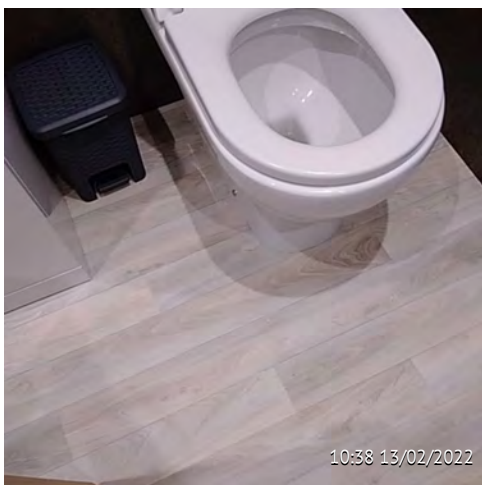
90 Ensuite

Mastic sealant required around perimeter of floor and the wall

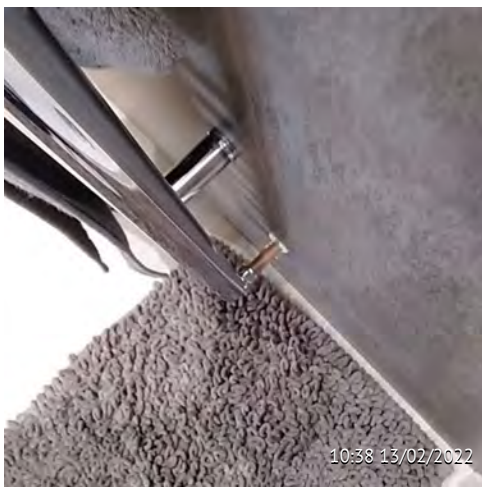
95 Ensuite

Poor decorative finish as shown in photograph

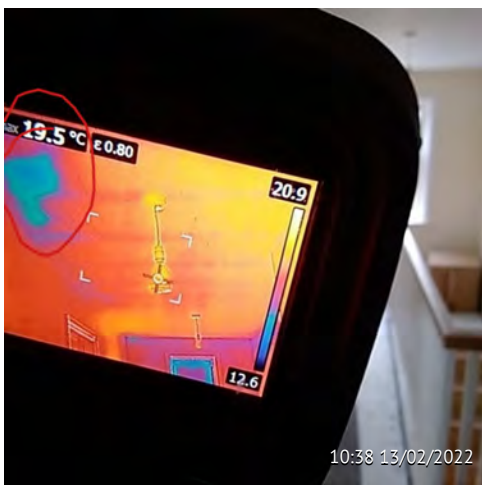
108 Landing
trade Plumber
Low radiator temp
Radiator requires bleeding
