NEW BUILD HOME SNAGGING INSPECTION

24 Park Way, Grange Heath, Co. Dublin

Sunday 13 February 2022

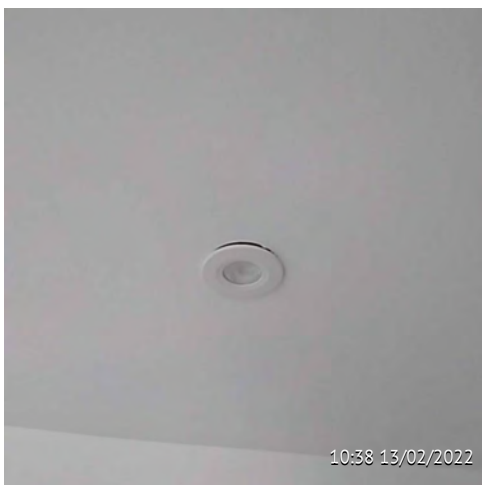
80 Bathroom
trade Decorator
Make good decorative finish to ceiling

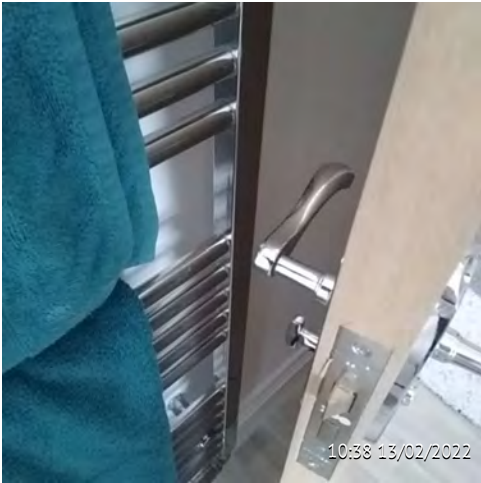
81 Bathroom
trade Carpenter
Door stop required
