NEW BUILD HOME SNAGGING INSPECTION

24 Park Way, Grange Heath, Co. Dublin

Sunday 13 February 2022

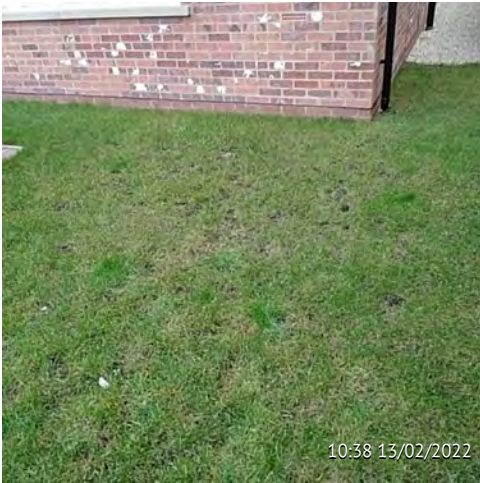
2 Front Garden

Ground firm and dry on day of inspection

Evidence of previous water logging....turf thin and dying offbuilder investigate / comment

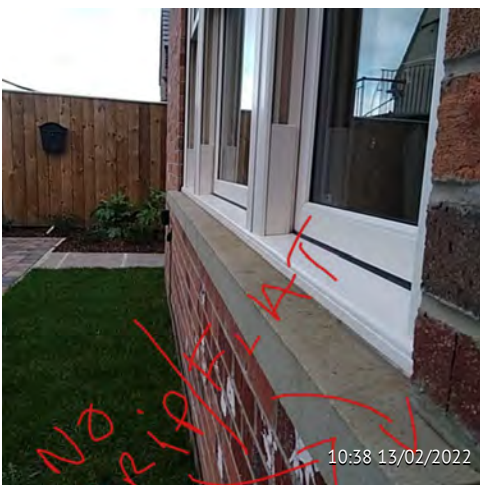
4 All Window Cills

Poor window cill designwindows cills should
Not encourage water to sitthis causes long term damage to stone
and concrete

Cills should be designed to shed water away from the property by
means of a sloping cil. And and underside dripthis detail used may
be the local vernacular ... but its not good design

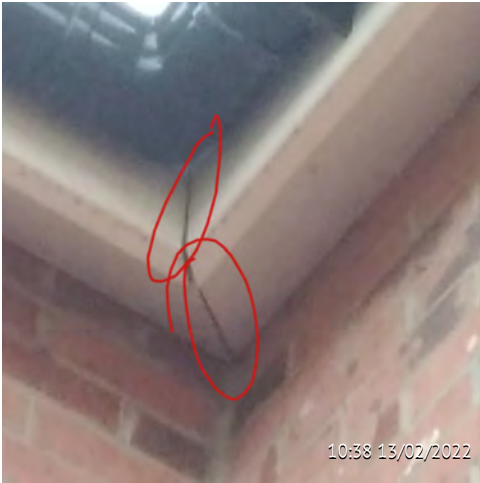
8 Fascia Above Front Door

Fascia and soffit jointer have not been used at joints

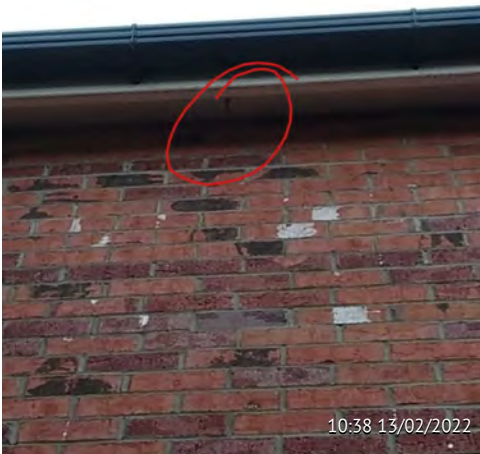
10 Front LHS Elevation

Soffit jointer not used

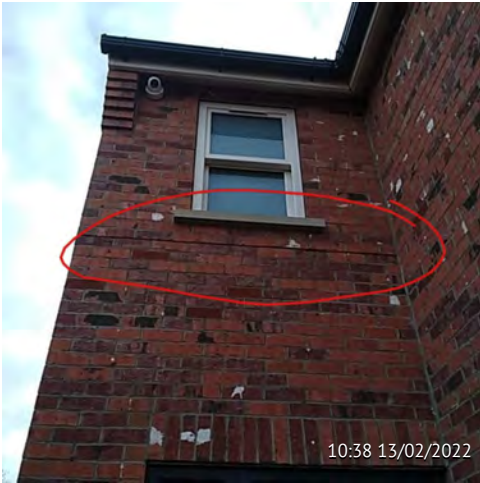
11 Front Elevation

Pointing missing in brickwork

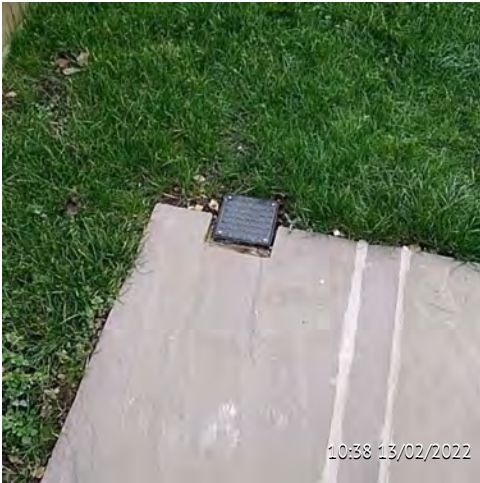
17 Rodding Eye Set Into Paving

Pointing required around

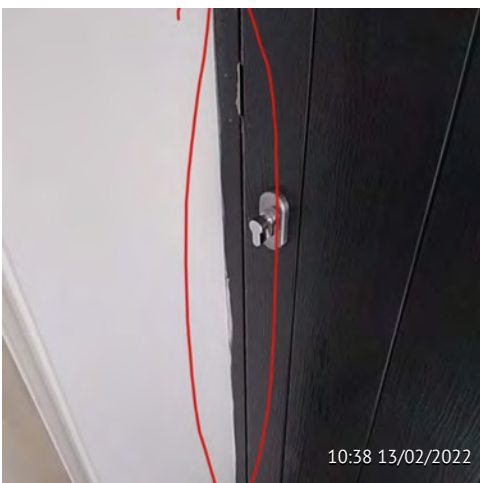
19 Front Entrance Door

Clean off overpaint

Door would benefit from a handle being fittedthumb turn not designed to be used as a handle ...its a locking mechanism

Door has to be pushed forwards for locking mechanism to engage...please adjust

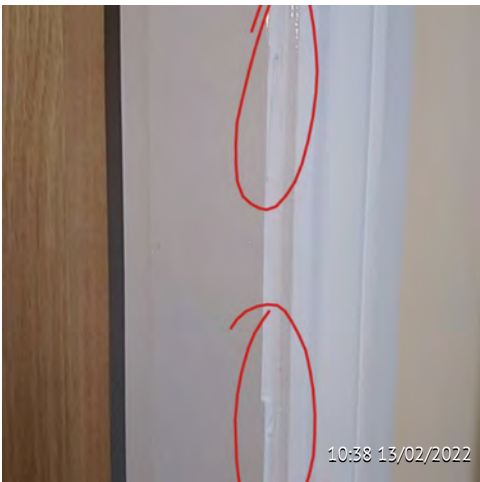
28 Hallway

Damage to door frame simply decorated

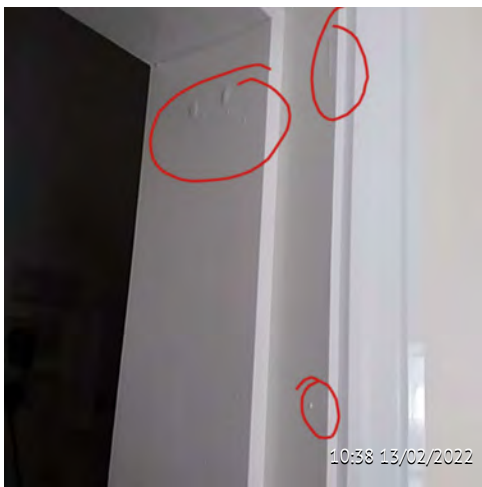
39 Typical Door Frame

Note premature Yellowing of paint finish.....caused by lack of daylight to paint , builder should choose paint formulations that can last the defects liability period

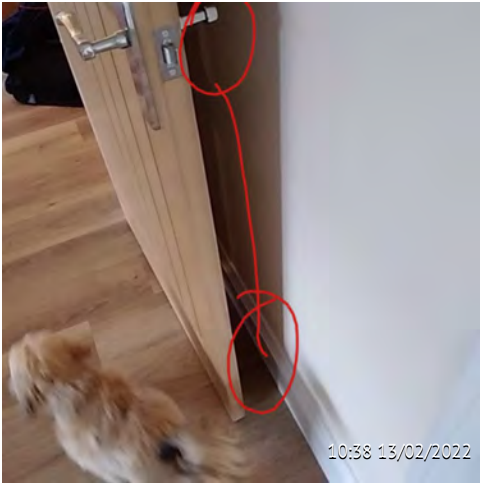
42 Lounge

Door stop required to prevent damage to wall

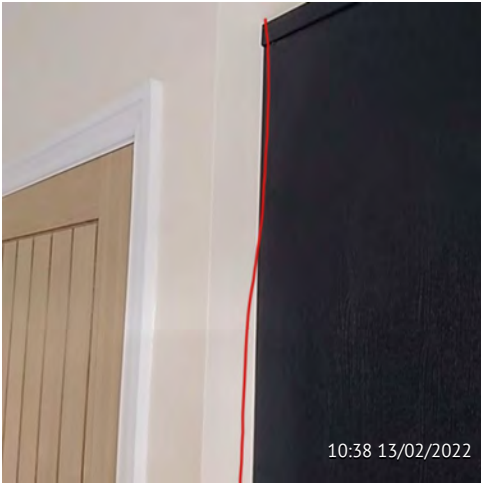
51 kitchen
trade Decorator
Mastic seal required

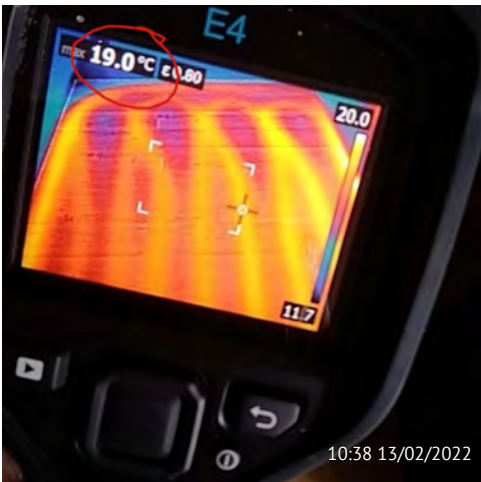
52 Kitchen
trade Decorator
Mastic sealant required

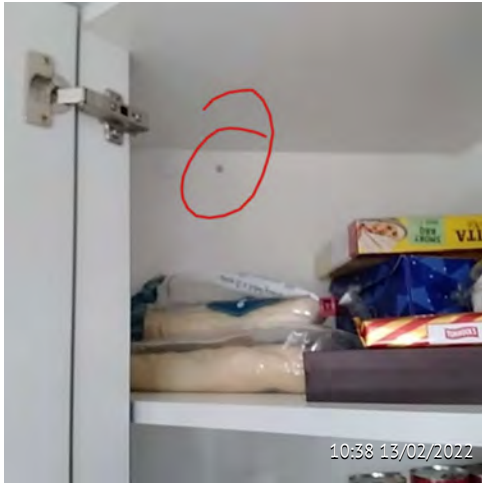
57 Kitchen

Cover cap missing

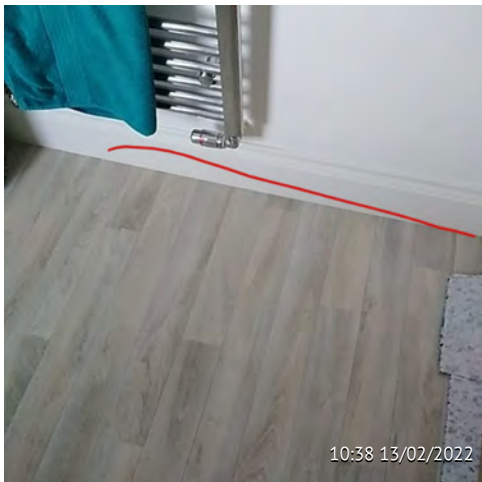
71 Bathroom

Mastic sealant required around the perimeter of the room

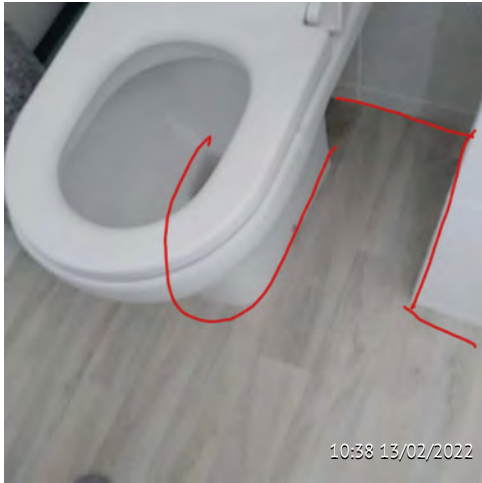
77 Bathroom
trade Decorator
Mastic sealant required

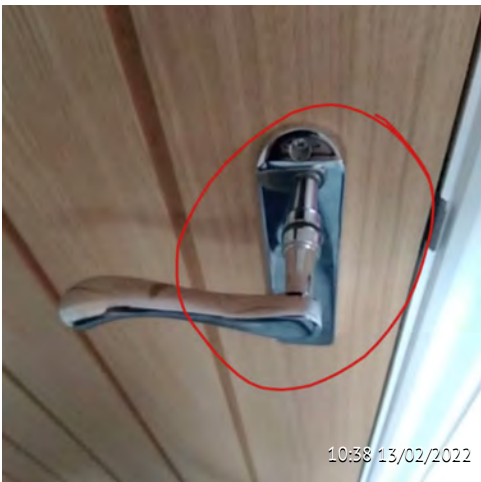
83 Bedroom Rear
trade Carpenter
Door rattles in the frame

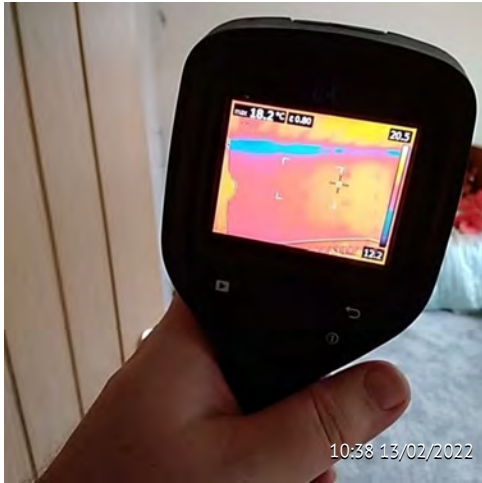
110 Front Bedroom Ceiling

Builder to investigate and comment on results of thermal imaging ...all rooms of this side of the building show a heat loss in the loft along the line where wall meets ceiling

Suggests insulation is not consistent at this point in loft

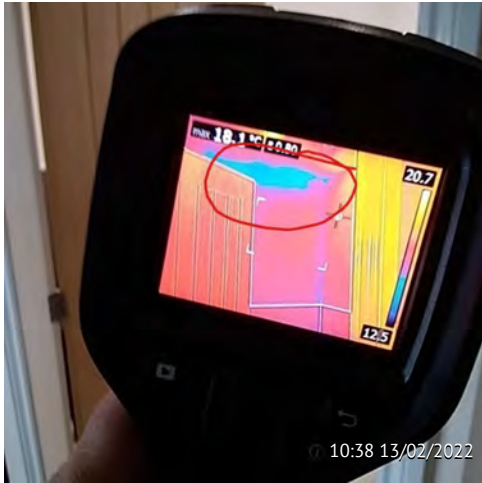
89 Ensuite

Builder to investigate and comment on results of thermal imaging ...all rooms of this side of the building show a heat loss in the loft along the line where wall meets ceiling

Suggests insulation is not consistent at this point in loft

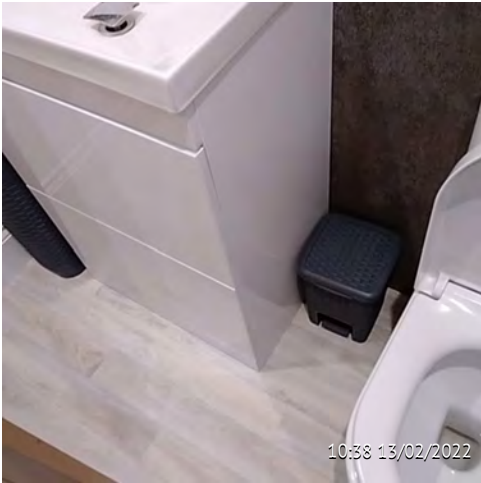
92 Ensuite

Mastic sealant required to all areas shown in photograph

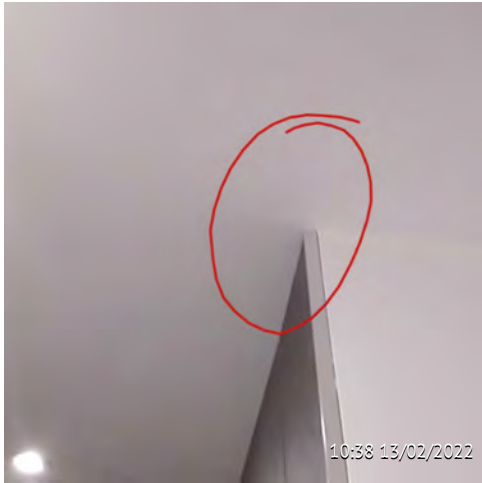
95 Ensuite

Poor decorative finish as shown in photograph

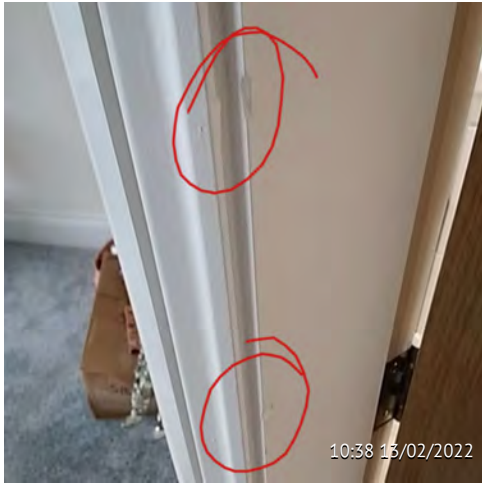
98 Ensuite

Example of typical damage to door frame

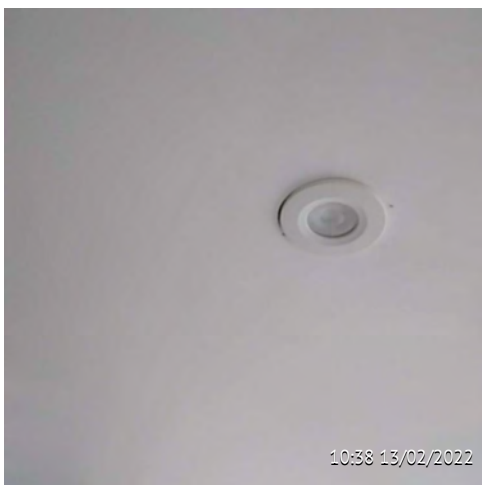
100 Bedroom Front

Make good decorative area shown in photograph

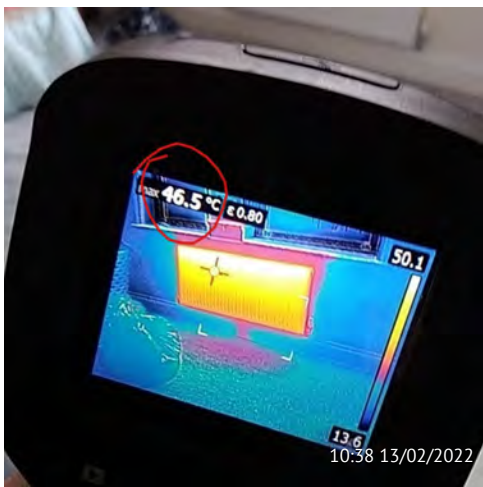
102 Bedroom Front

trade Plumb
Radiator temp low ...setting on full

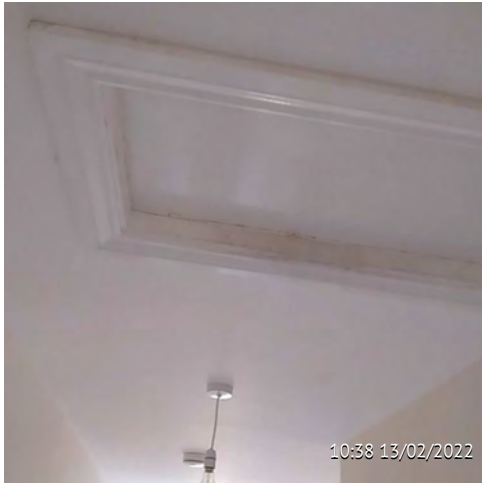
104 Loft Hatch

Unusual sizemaking access and use somewhat limited

Finishing Around hatch and frame required attention

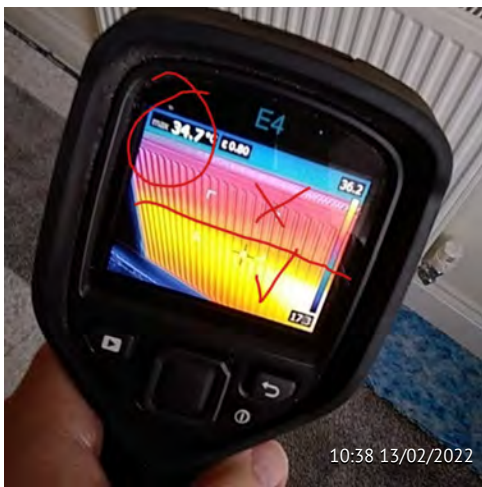
108 Landing
trade Plumber
Low radiator temp
Radiator requires bleeding
